CASE STUDIES

DAM REMOVAL

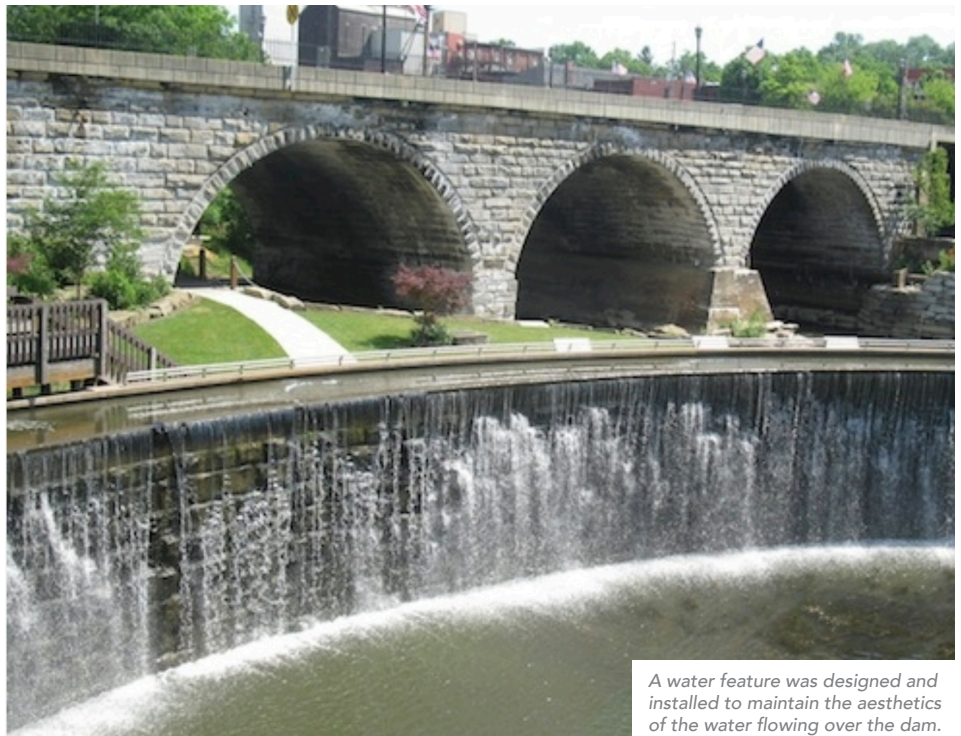
A water feature was designed and installed to maintain the aesthetics of the water flowing over the dam.

The Kent Dam is also a good example of a project that was able to achieve the dual goals of habitat connectivity and historic preservation. By creating a public park at the dam site, the history of the site and sense of place was able to be preserved and possibly enhanced. In addition, by adding a water feature to the arch dam artifact, the aesthetic and acoustic experience of being near a waterfall was preserved.

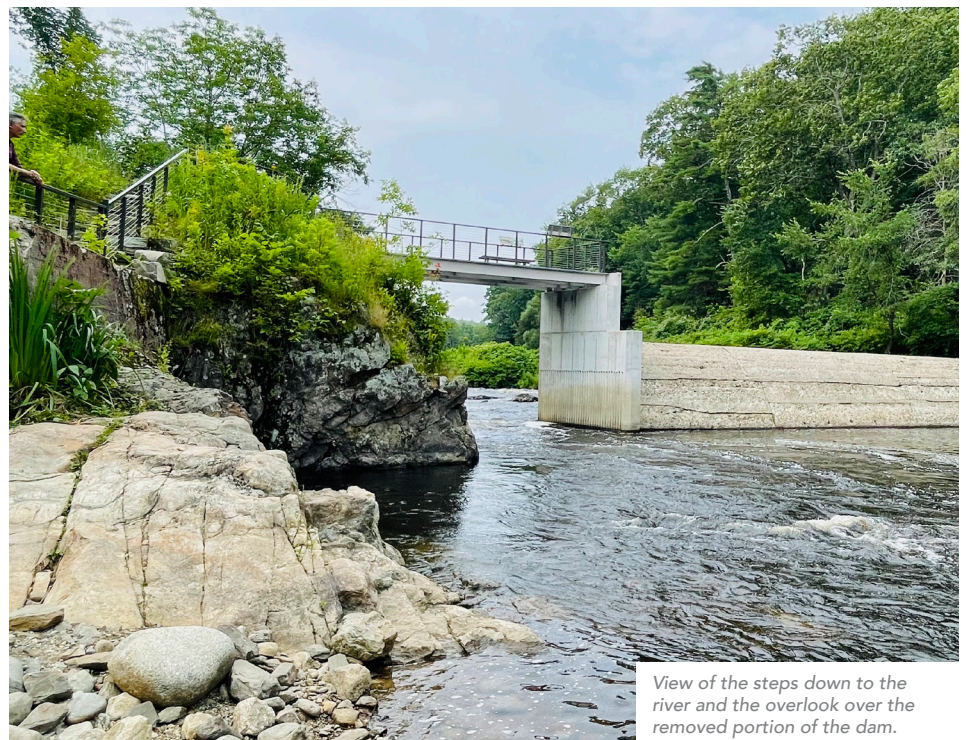
View of the steps down to the river and the overlook over the removed portion of the dam.

Although outside of the Narragansett Bay watershed, the High Tide Dam in Alna provides a case study of a partial removal of a dam. The project consisted of the removal of 26 feet of the west side of the dam, the construction of an overlook in its place, construction of a retaining wall at the foundation of an old mill, and the addition of a path to the river. The modification of the Alna dam is the second project in a series of three projects aiming to improve fish passage in the Sheepscot River, improve public safety and access, and honor the history at the individual sites. The first of the three projects, completed in 2018, was the removal of the Coopers Mills Dam in Whitefield upstream of the Head Tide Dam. The third project, at Branch Pond Mill Dam in the town of China, Maine, will stabilize the dam and install a fishway. Together the project aims to improve fish passage on the Sheepscot River which is home to the southernmost genetically unique wild populations of Atlantic salmon remaining as well as 11 other species of migratory species.

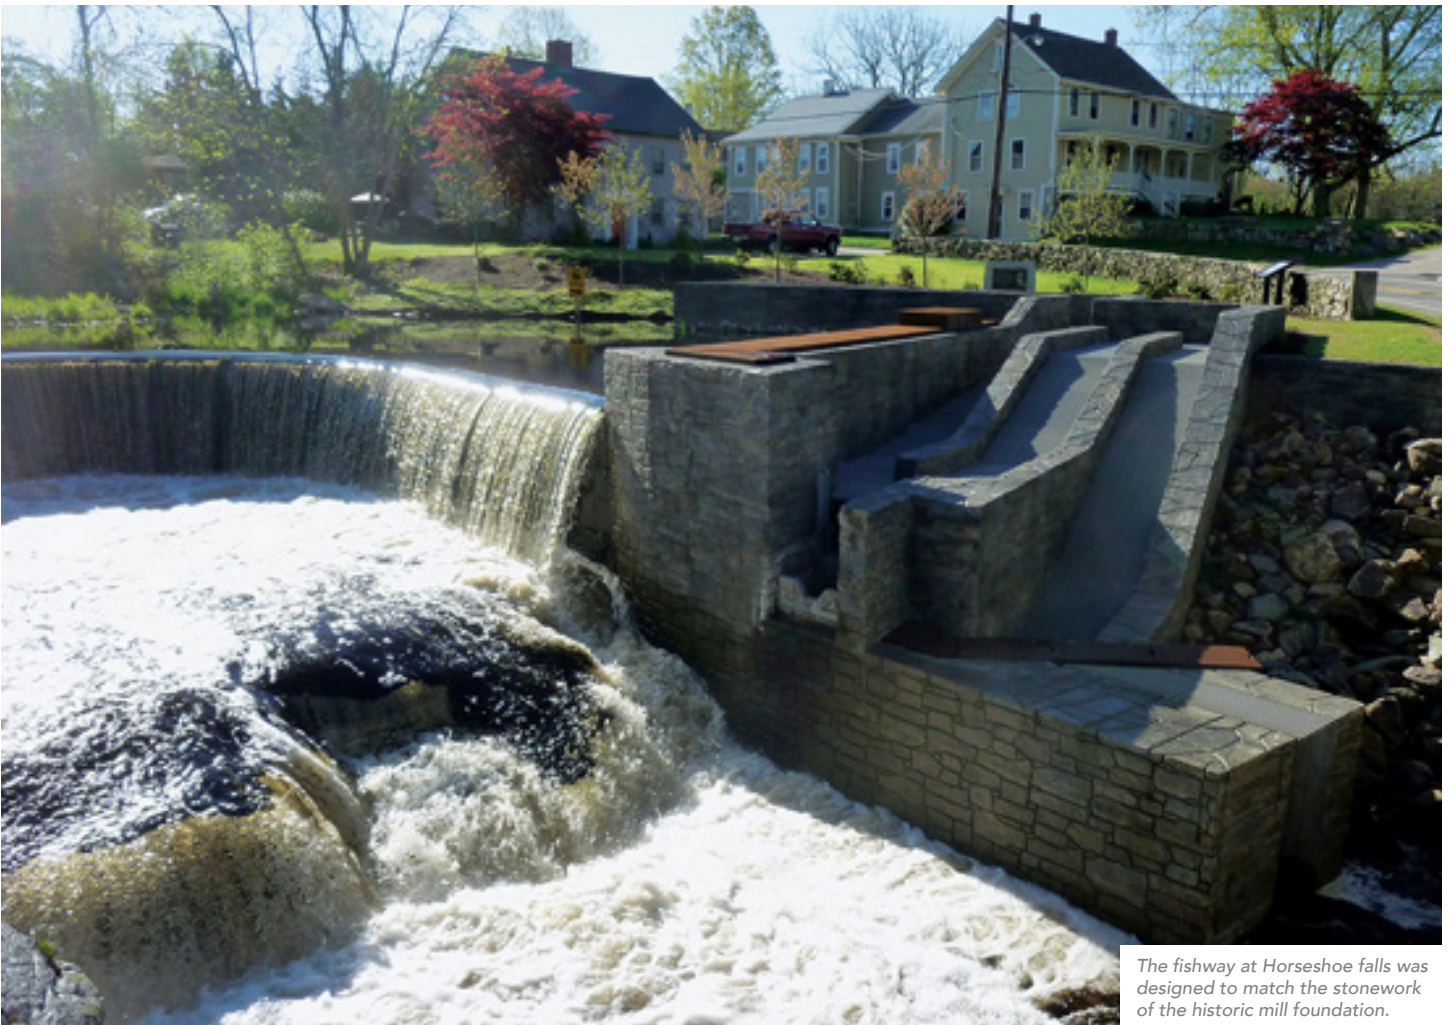
The fishway at Horseshoe falls was designed to match the stonework of the historic mill foundation.

designed to allow alewife and eel passage. To ensure the fishway did not look out of place, engineers shaped the exterior of the fishway to match the stones of the original mill foundation on the opposite bank.

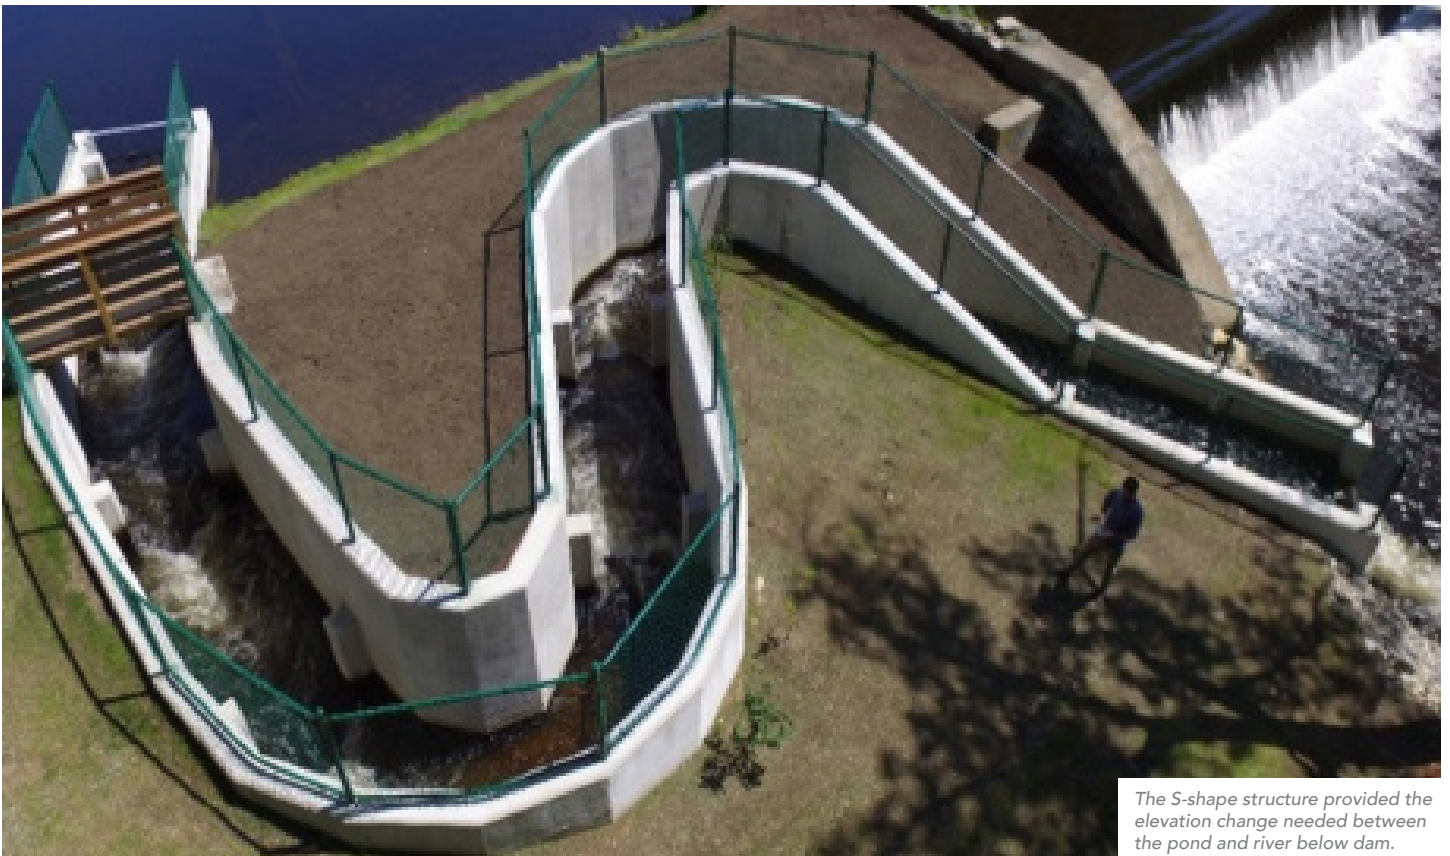
The S-shape structure provided the elevation change needed between the pond and river below dam.

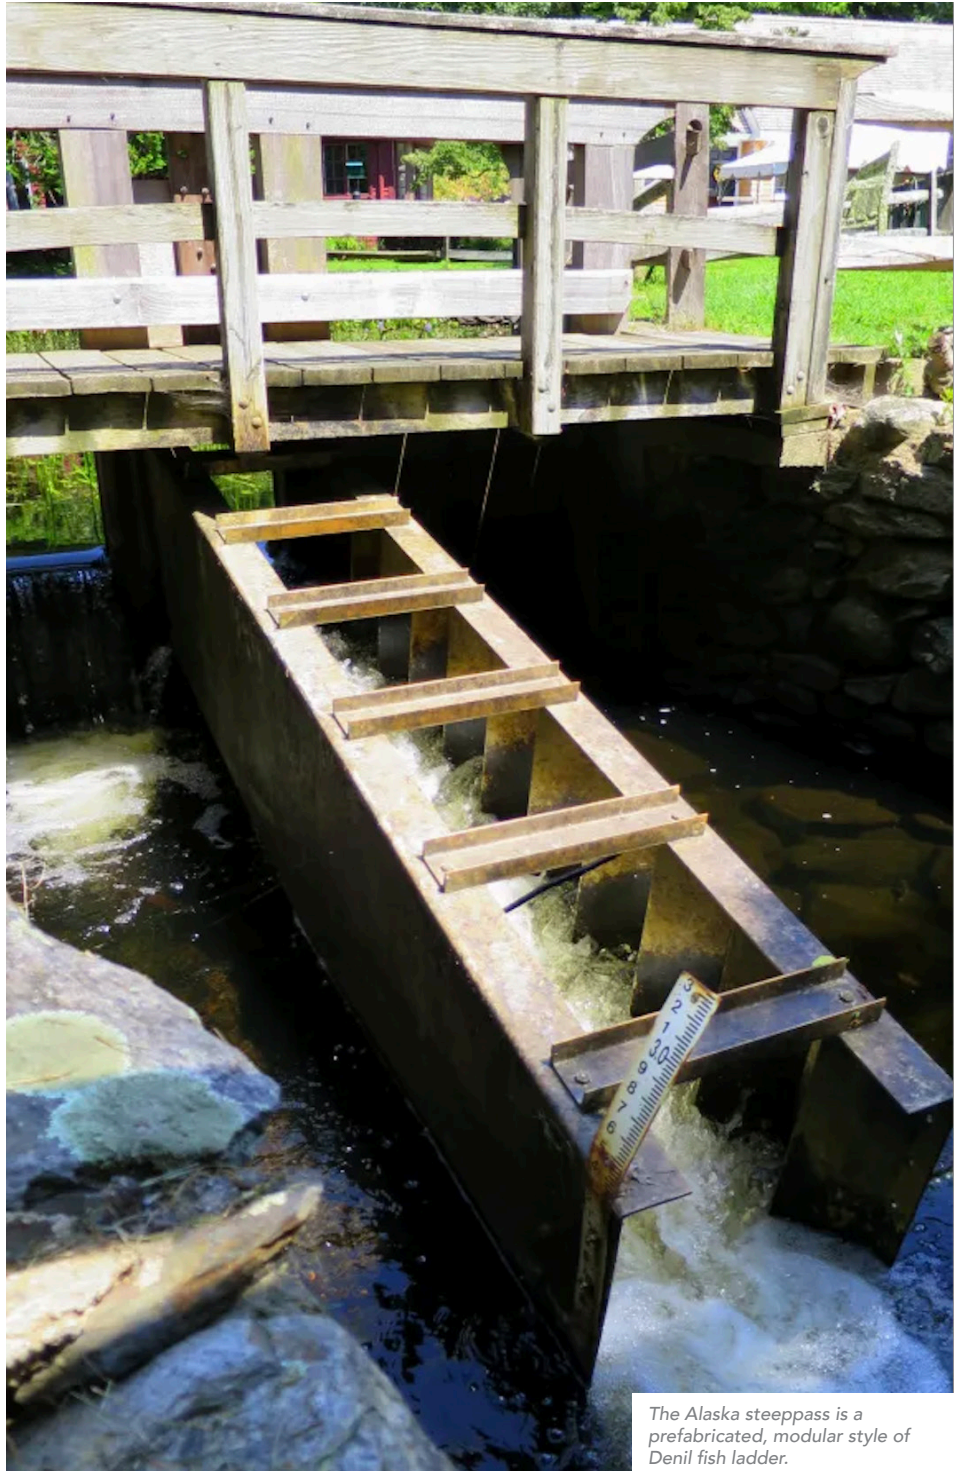
The Alaska steeppass is a prefabricated, modular style of Denil fish ladder.

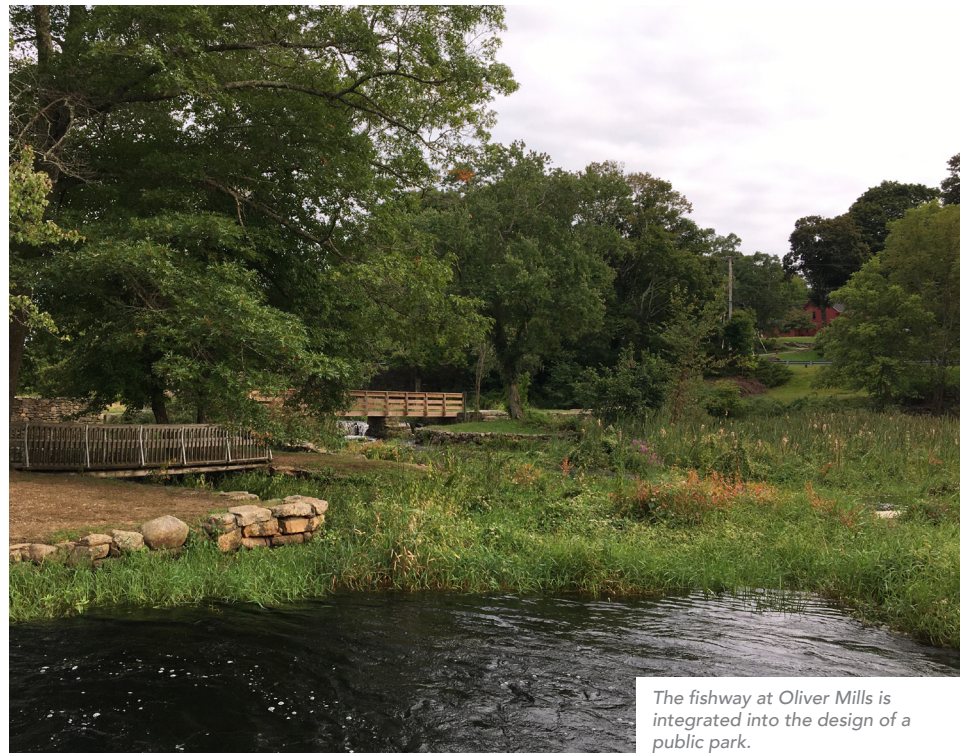
The fishway at Oliver Mills is integrated into the design of a public park.

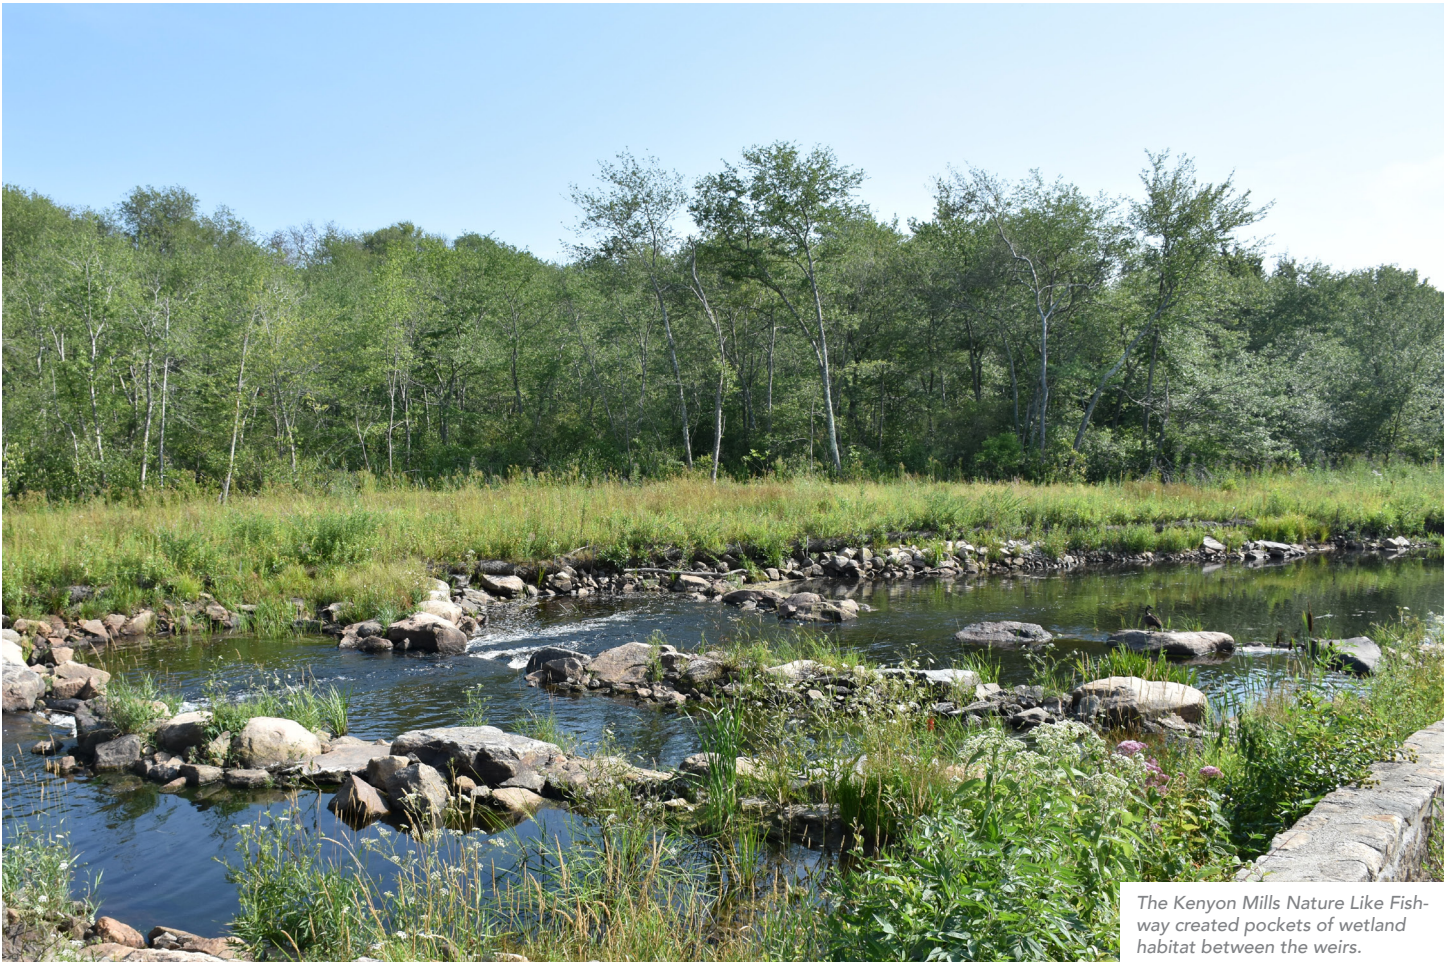
The Kenyon Mills Nature Like Fishway created pockets of wetland habitat between the weirs.

Creating a nature-like fishway provided fish passage while allowing for the impoundment to remain upstream, providing water for fire suppression and ensuring that the upstream wells would not lose drinking water. In addition, during low flow, the rock ramps provide diverse habitat along the river's edge.

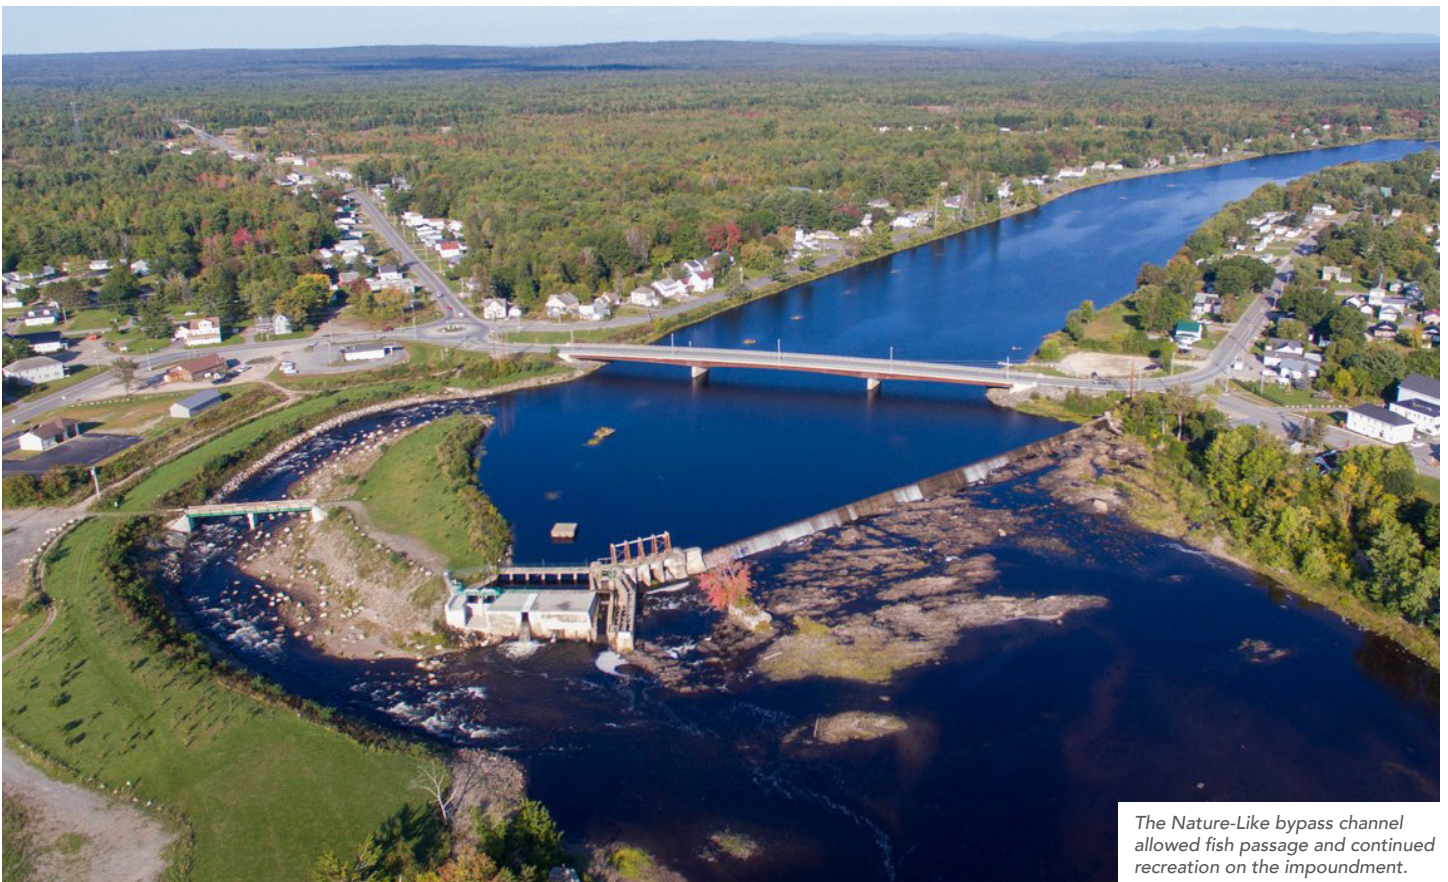
The Nature-Like bypass channel allowed fish passage and continued recreation on the impoundment.

resemble a natural stream, reflecting ideal conditions for migratory species. In order to re-grade the sloped site into a channel, bedrock was blasted and strategically placed throughout the stream bed to create roughness and water perturbation critical to the health of migrating fish.
